## Property Inspection Report

*Tyler Home Inspections, LLC*

110 Village Green Court  
Lilburn, GA 30047

Phone: 512-775-4988  
Date of Inspection: March 16, 2011  
Time: 0900  
Weather Conditions: Clear/50 degrees

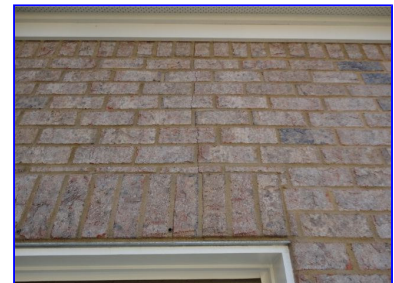
Brick veneer above garage door opening has settling cracks at mortar and bricks. I recommend a masonry contractor make repairs at brick veneer as required.

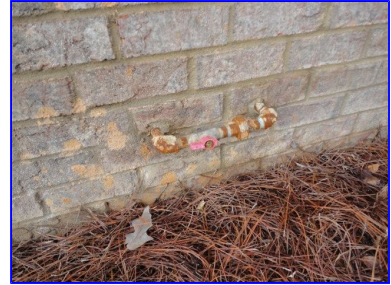
Exterior fireplace gas cut off at right side has rusted gas pipes. I recommend removing rust and painting pipes with a rust proof paint to prevent further rusting.

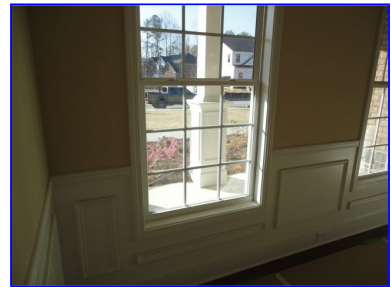
The front double hung window at dining room has become loose at bottom track and difficult to operate. The frame is un-caulked at right lower interior side of window. I recommend repairs and/or adjustments as needed at front dining room window an necessary.

The front double hung window at dining room has become loose at bottom track and difficult to operate. The frame is un-caulked at right lower interior side of window. I recommend repairs and/or adjustments as needed at front dining room window as necessary.

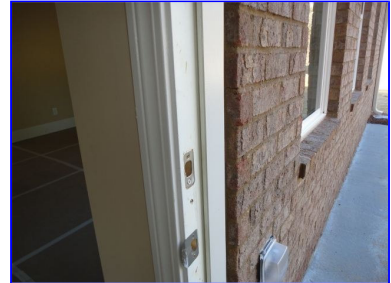
Weather stripping not installed at rear and front exterior doors. I recommend properly installing weather stripping as required. The metal lintels at brick veneer openings is not primed or painted. I recommend priming and painting metal lintels to prevent rusting as required.

Weather stripping not installed at rear and front exterior doors. I recommend properly installing weather stripping as required.

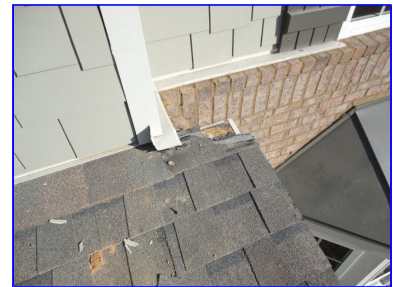
We observed a small damaged section of roofing at front porch at rear right roof near outside of corner near flashing. Exposed roof sheathing is present with damaged shingles. We recommend

clearing nails and debris from porch roof surface as required. We recommend repairs as required at front porch.

We observed a small damaged section of roofing at front porch at rear right roof near outside of corner near flashing. Exposed roof sheathing is present with damaged shingles. We recommend repairs as required at front porch.

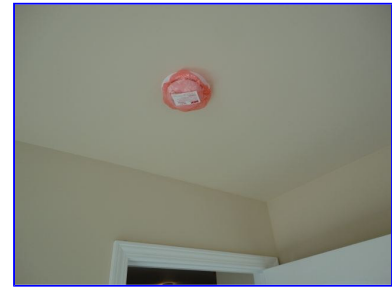
Smoke detectors were dust covered and not inspected at time of inspection. Replace detector batteries every 6 months. It is recommended that smoke detectors are replaced every 10 years. Carbon monoxide detectors not installed in home. We recommend properly installing CO detectors.

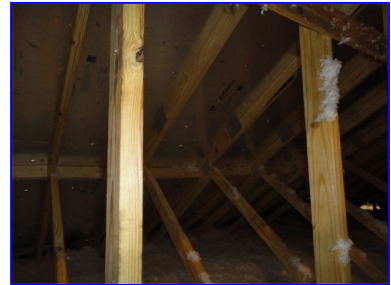
Limited views at roof sheathing due to installation of Tech Shield Barrier.

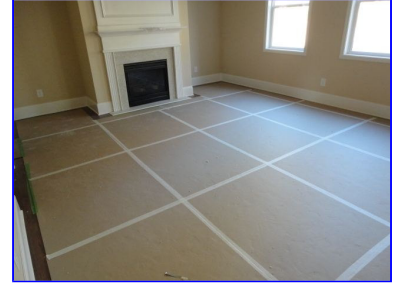
Limited views at wood floors at main floor due to protective paper.

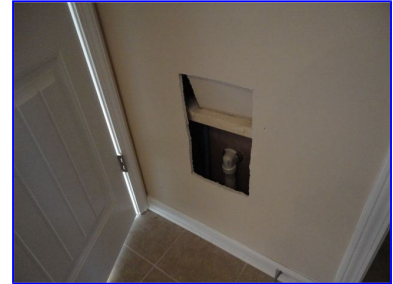
Hole at drywall at jack and jill bathroom at second floor. We recommend repairing drywall as required.

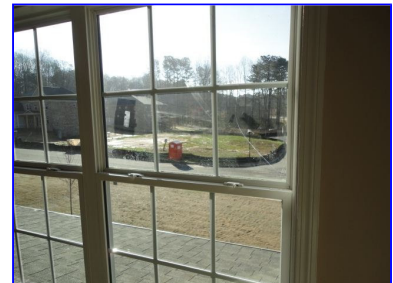
Cracked upper sash at second floor middle bedroom. I recommend replacing window as required.

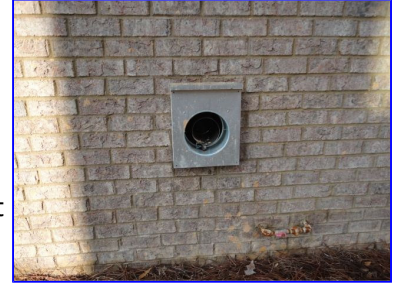
Sealed Heat Glo fireplaces were not inspected at time of inspection due to pilot lights not being lit. The exterior flue cover isn't installed at right side. I recommend properly installing flue at right side and re-inspecting fireplaces once pilot lights are lit.

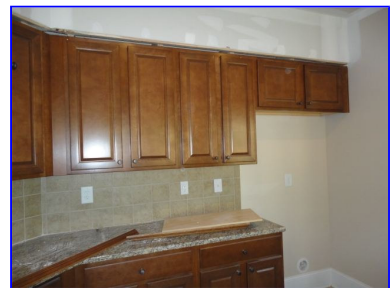
Cabinets at kitchen are under construction at time of inspection.

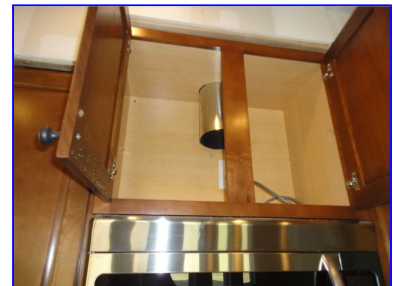
Exhaust fan and duct are being installed at time of inspection. I recommend re-inspecting once repairs and installation is complete.

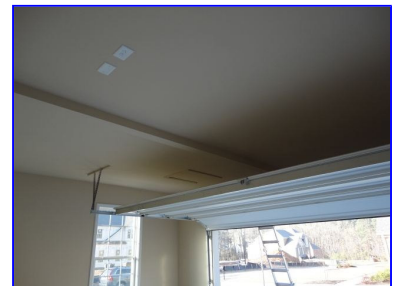
Be advised that latching devices and hardware are not present at garage door. Opener not installed at garage door. I recommend installing hardware at garage door as required.

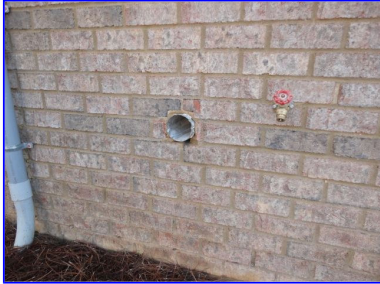
Exterior vent covers not installed
